## **GAA PFC Distortion Investigation**

This report was produced by the GAA to investigate the issues around the distortion/deformation of PFC during the hot dip galvanizing (HDG) process.

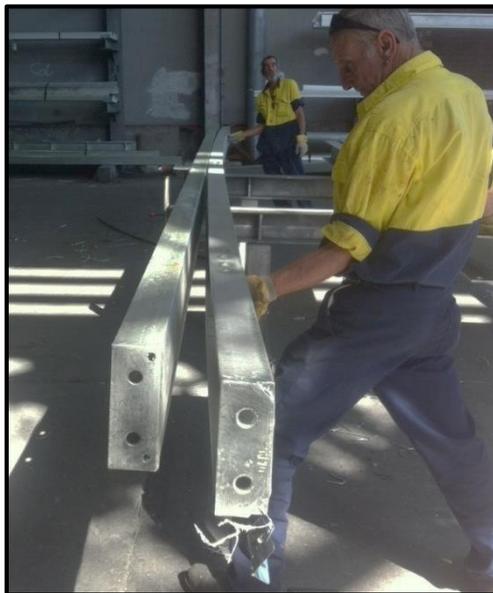
*Two identical fabricated PFC sections galvanized at the same time with vastly different deformation*

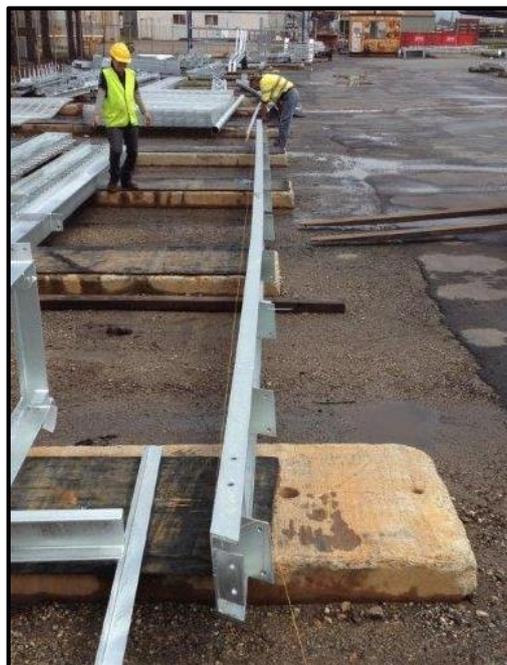
The main issue with deformation is when a PFC has had cleats or angle welded down one side. These are typically used as fascia’s by builders and architects. The welding of these cleats introduces fabrication stress and also stiffens up one side of the PFC section further exaggerating the already unsymmetrical geometry.

*A fabricated PFC that has distorted during the galvanizing process*

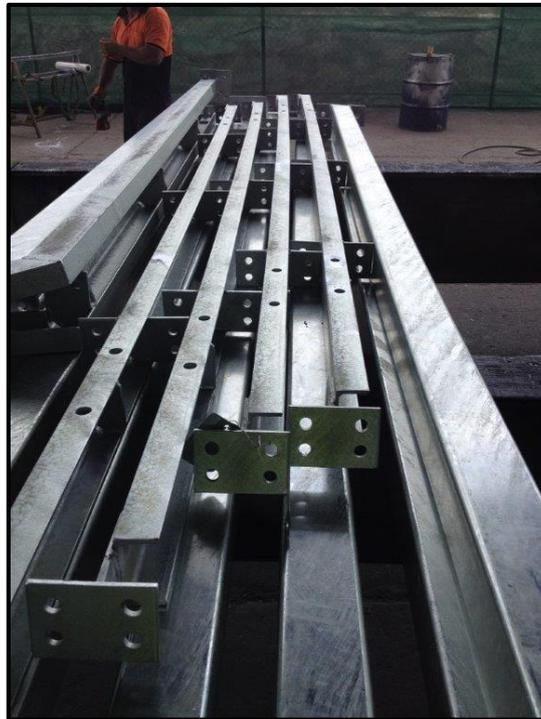
*Fabricated PFC sections with a shallow curve along the welded face*
