GAA PFC Distortion Investigation

This report was produced by the GAA to investigate the issues around the distortion/deformation of PFC during the hot dip galvanizing (HDG) process.

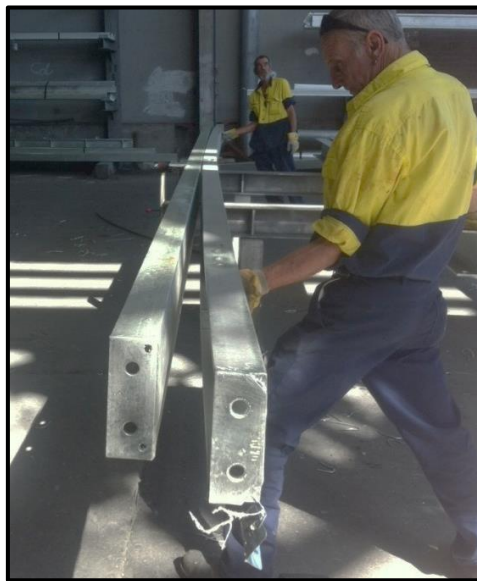
Two identical fabricated PFC sections galvanised at the same time with vastly different deformation

Because of the unsymmetrical geometry of PFC sections and the residual stresses that are present, when the articles enter the molten zinc bath the steel heats up and these residual stresses can “relax” and cause the steel article to deform. Due to the high stiffness of one plane of a PFC being offset from the centroid this deformation can be more severe than in other steel articles that have symmetric geometry (U beams, RHS etc.). The galvanizers also generally hang PFC sections by the ends and dip

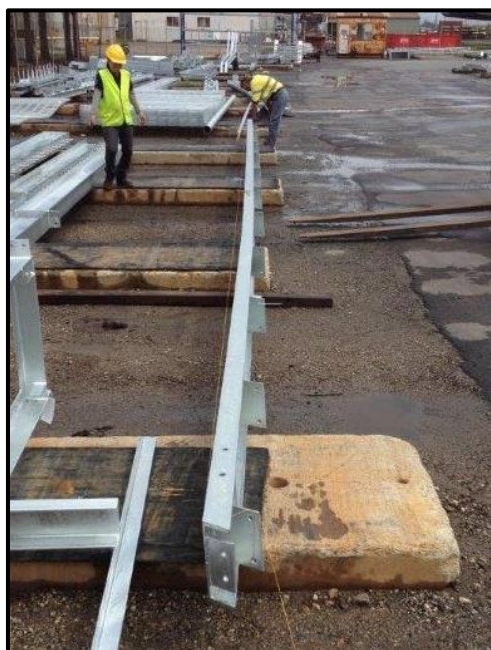
The main issue with deformation is when a PFC has had cleats or angle welded down one side. These are typically used as fascia’s by builders and architects. The welding of these cleats introduces fabrication stress and also stiffens up one side of the PFC section further exaggerating the already unsymmetrical geometry.

A fabricated PFC that has distorted during the galvanizing process

If deformation does occur, the sections are sent back to the fabricator to be straightened. Usually the client or the fabricator will wear the costs, and if this is unexpected it can result in a negative attitude towards the HDG process. Most of the time the fabricator will simply clamp the beams in place and jack the beams until the desired level of straightness is achieved. This is a simple process and something industry has come to expect to have to do. Some fabricators also have access to straighteners however these can only be utilized when dealing with straight, unfabricated sections.

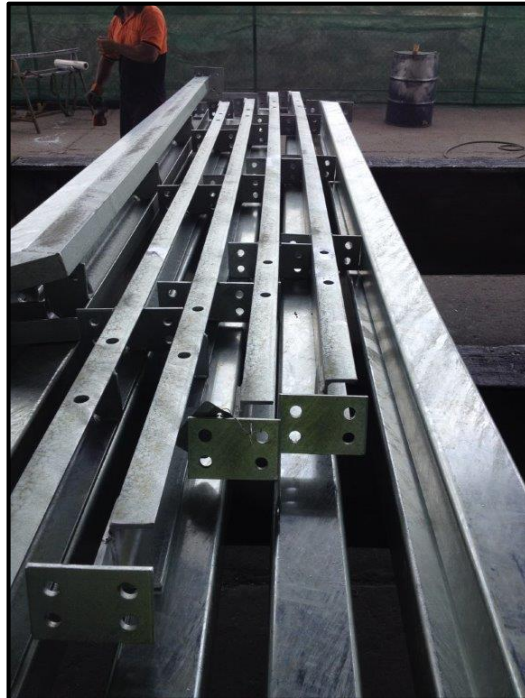
Fabricated PFC sections with a shallow curve along the welded face

- Letting customers know that there is a likelihood PFC sections will distort and there may be an extra cost to have them straightened
- Good fabrication practices
- Stress relief of welds if possible
- Discuss with galvanizers optimal hanging point locations and potential to air cooled
