TECHNICAL NOTE

Differing Appearance

Issue 1, April 2017

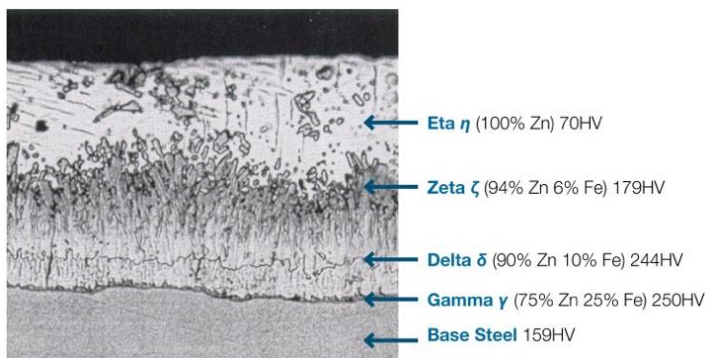
Figure 1: A photomicrograph which shows the alloy layers present in a typical galvanized coating.

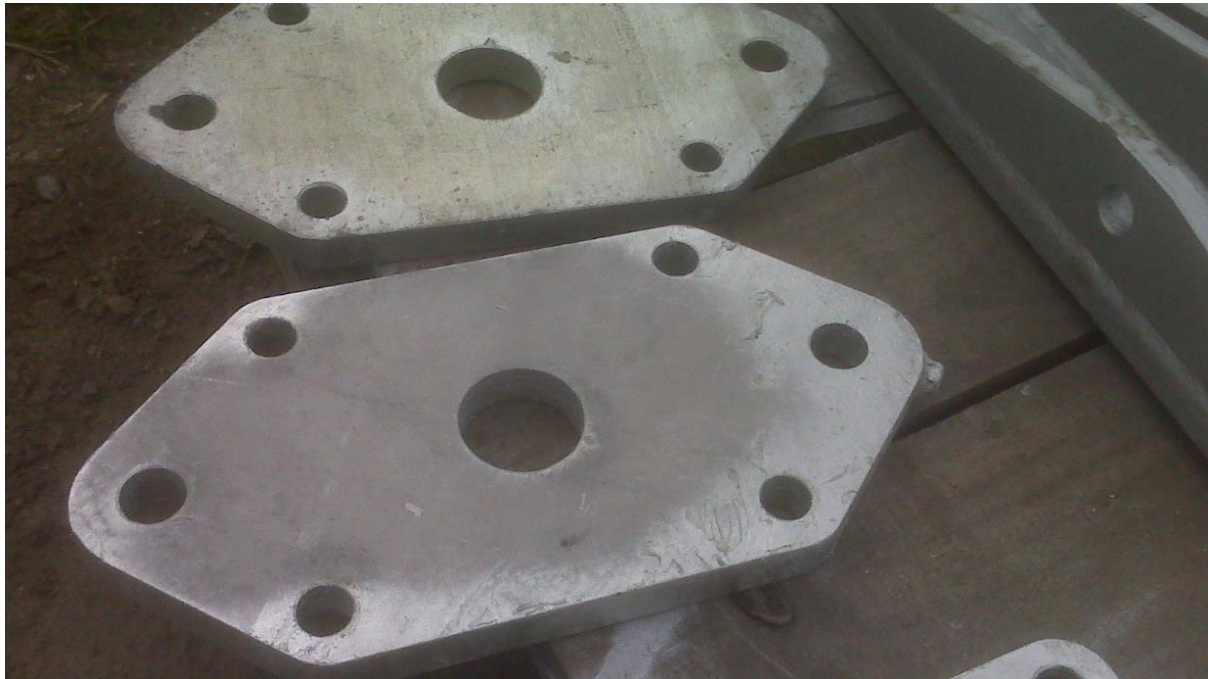
Figure 2: The thicker plate has cooled more slowly in the centre, causing a dull grey finish where alloy layers have grown to the surface.

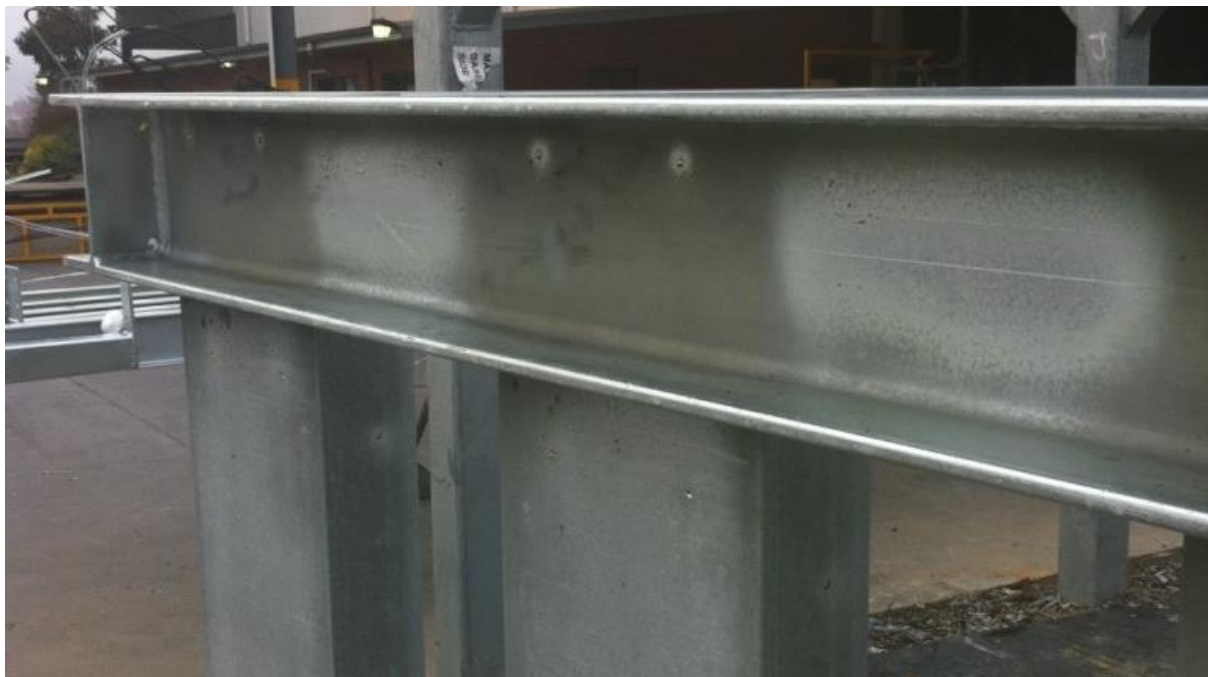
Figure 3: The thick steel behind the beam has caused slower cooling of the web in places, resulting in a duller coating.

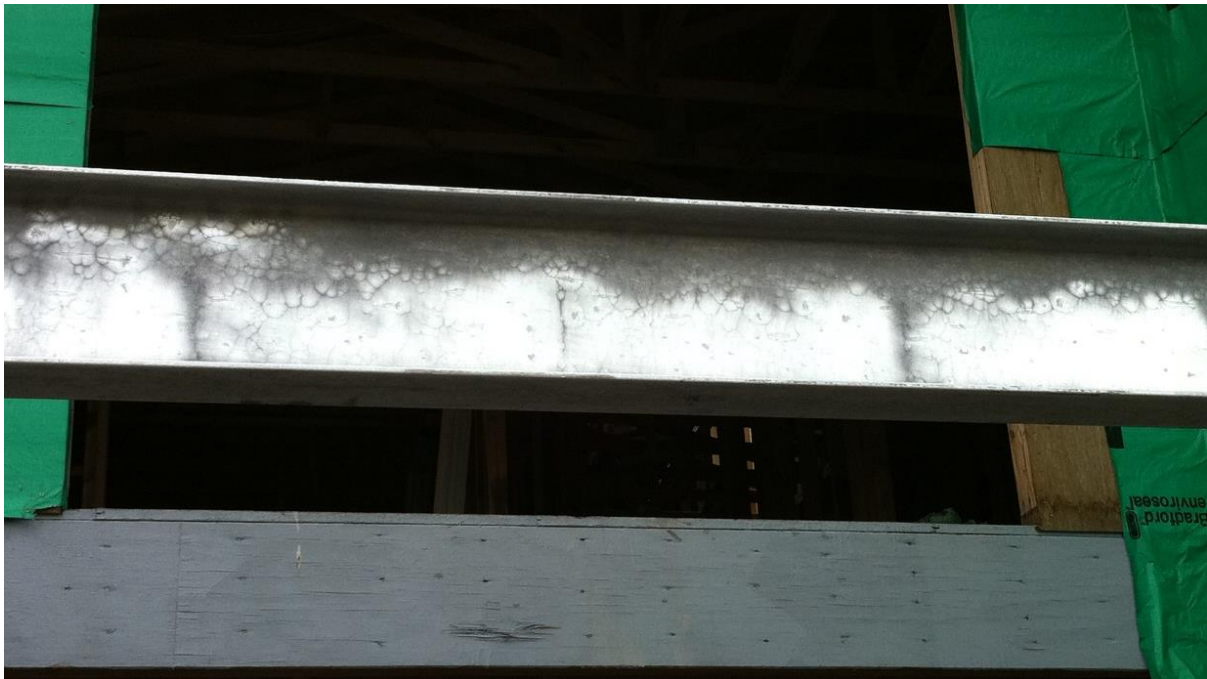
The cooling rate after galvanizing also influences alloy layer appearance. When articles have thicker steel areas, they retain heat for longer, which can allow the reaction between the zinc and steel to continue if the temperature stays sufficient. This can cause the alloy layers to grow to the surface in places and develop duller coatings as in Figures 2-3. While the article is being withdrawn, its lower surface may be exposed to radiant heat from the bath or molten zinc draining from the article for a longer period, especially if hung at an angle close to horizontal. This heat at the lower surface can allow the reaction between the zinc and steel to continue and result in a dull appearance. This is the probable cause for the appearance of the coatings seen in Figures 4-7.

Figure 4: The darker section of this beam has likely spent more time over the galvanizing bath while the zinc drains off. The mottled appearance is indicative of the alloy layers growing to the surface in some places.

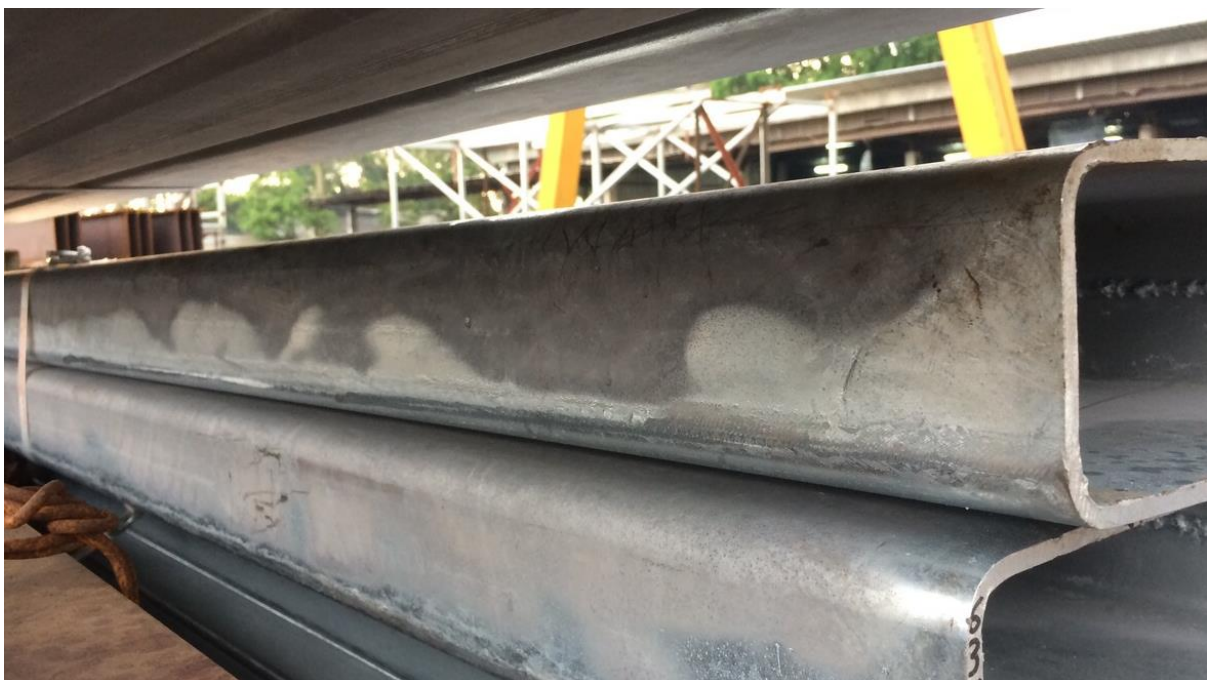
Figure 5: A well-defined barrier between shiny and dull sections could be a result of prolonged bath temperature exposure or the zinc cooling and losing fluidity during run off.

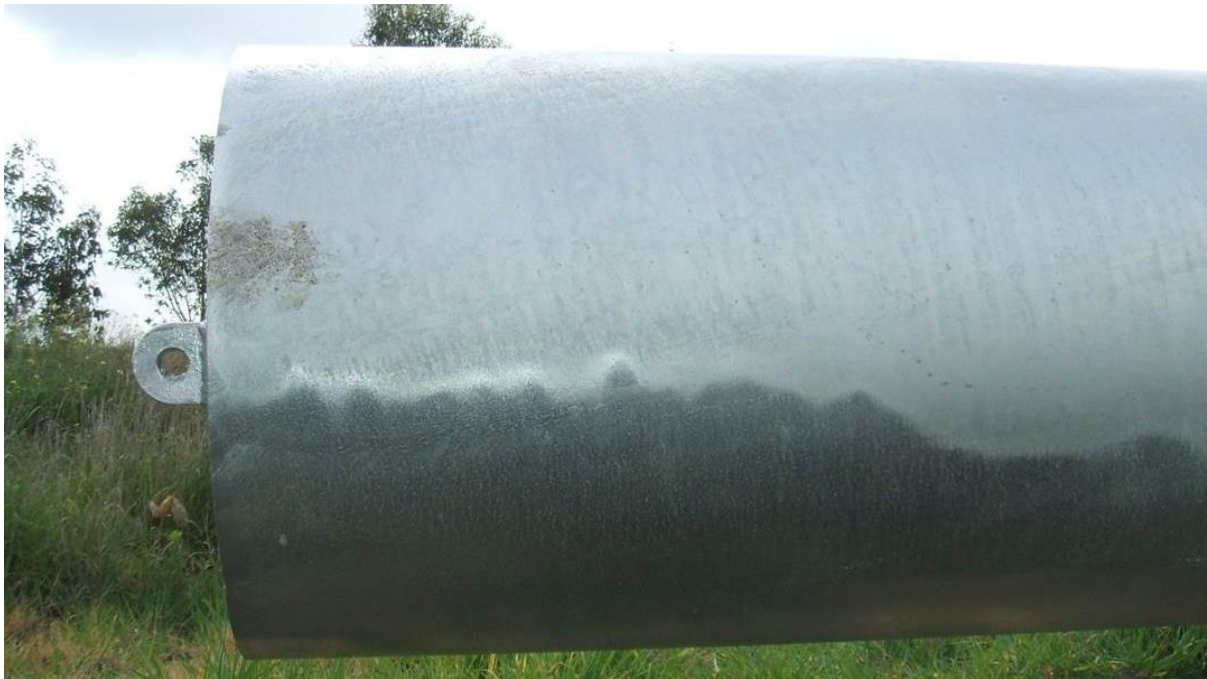
Figure 6: The duller section of the pipe has been exposed to the bath temperature for longer, with the shiny section consisting of pure zinc.

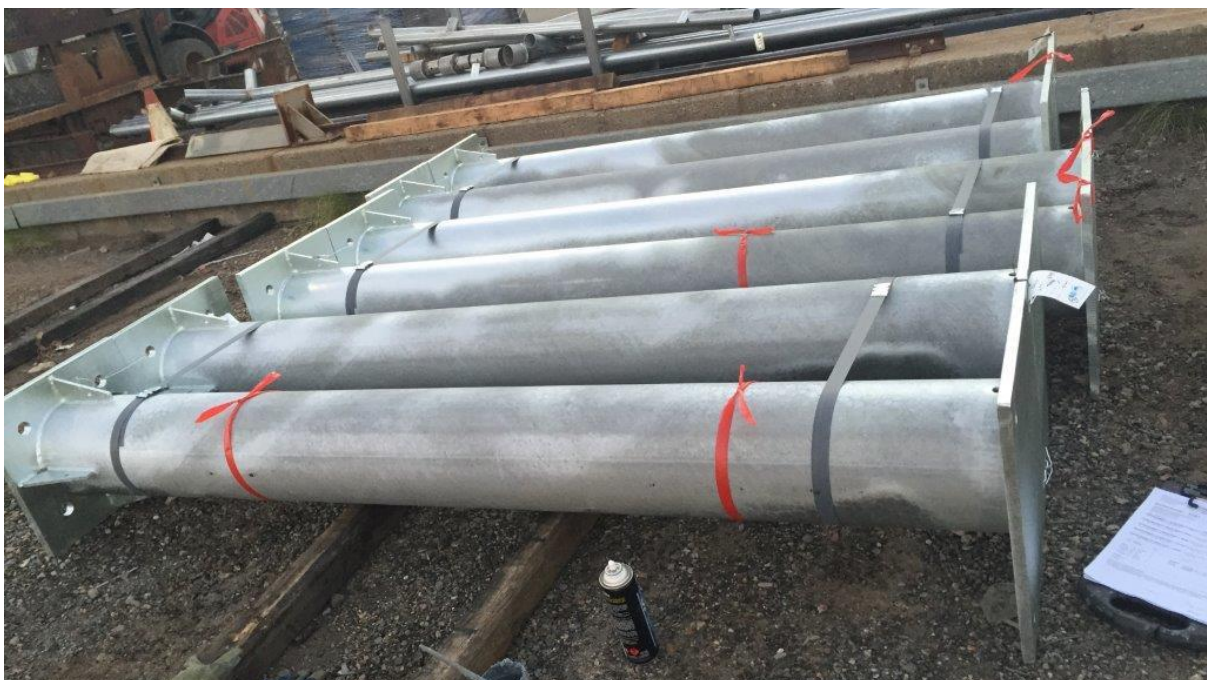
Figure 7: A small shiny section can be seen in the bottom right of the image, likely caused by the surface cooling at a different rate.

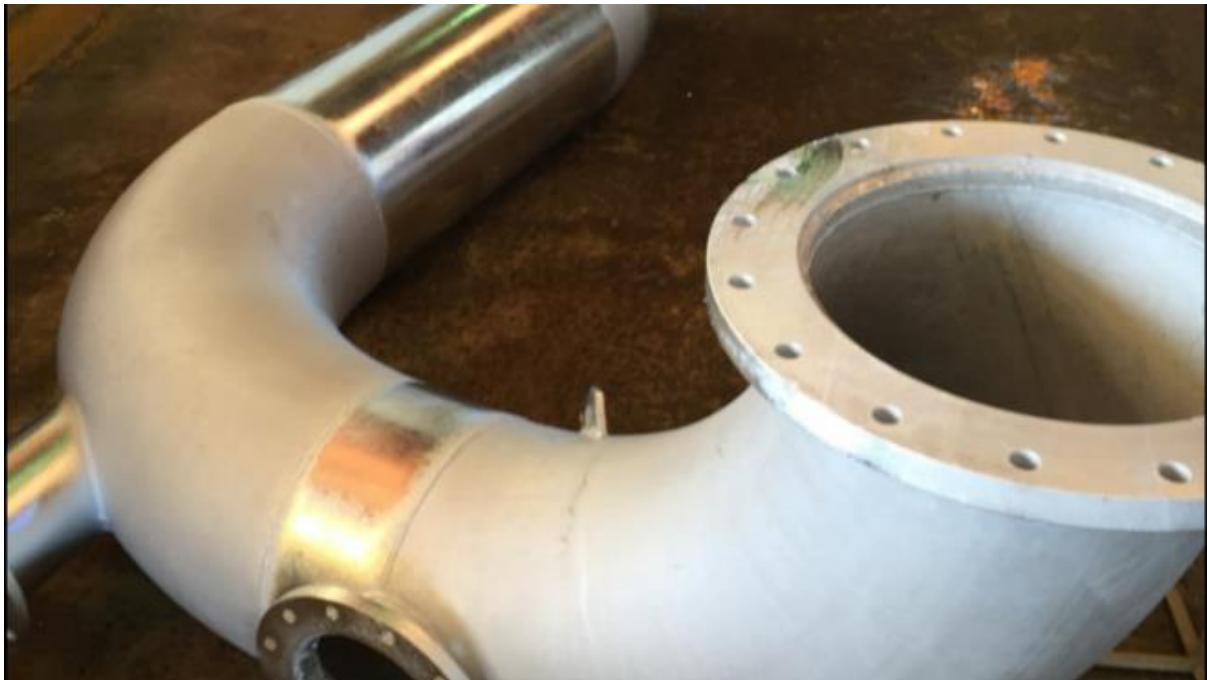
For a fabricated article, if the steel sections comprising the article have a large variation in steel composition (i.e. different sections use steel from different Categories in Table 9.1 of AS/NZS 2312.2), their differing reactivity will generally result in a varied appearance across the different steel sections, as seen in Figures 8-12.

Figure 8: Steels with different chemical compositions on the straight and curved sections have been used, resulting in the straight sections being shiny and the curved sections dull.

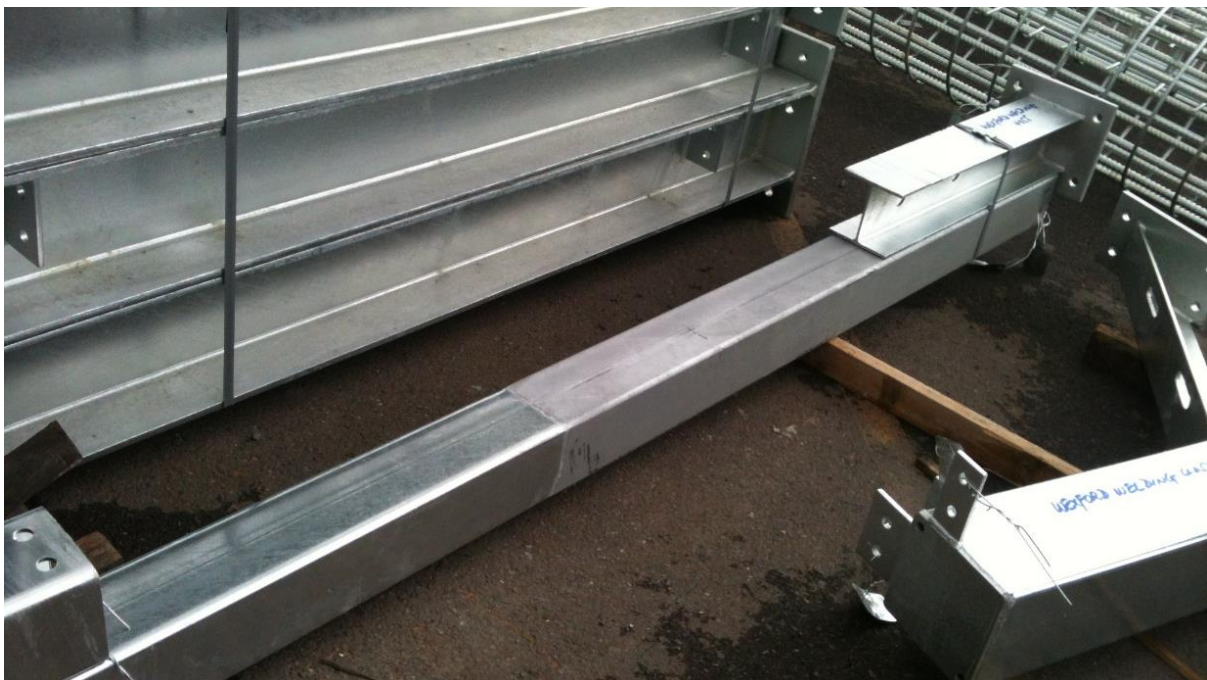
Figure 9: Steels of different compositions have been welded together in a straight square hollow section, resulting in the differing appearance.

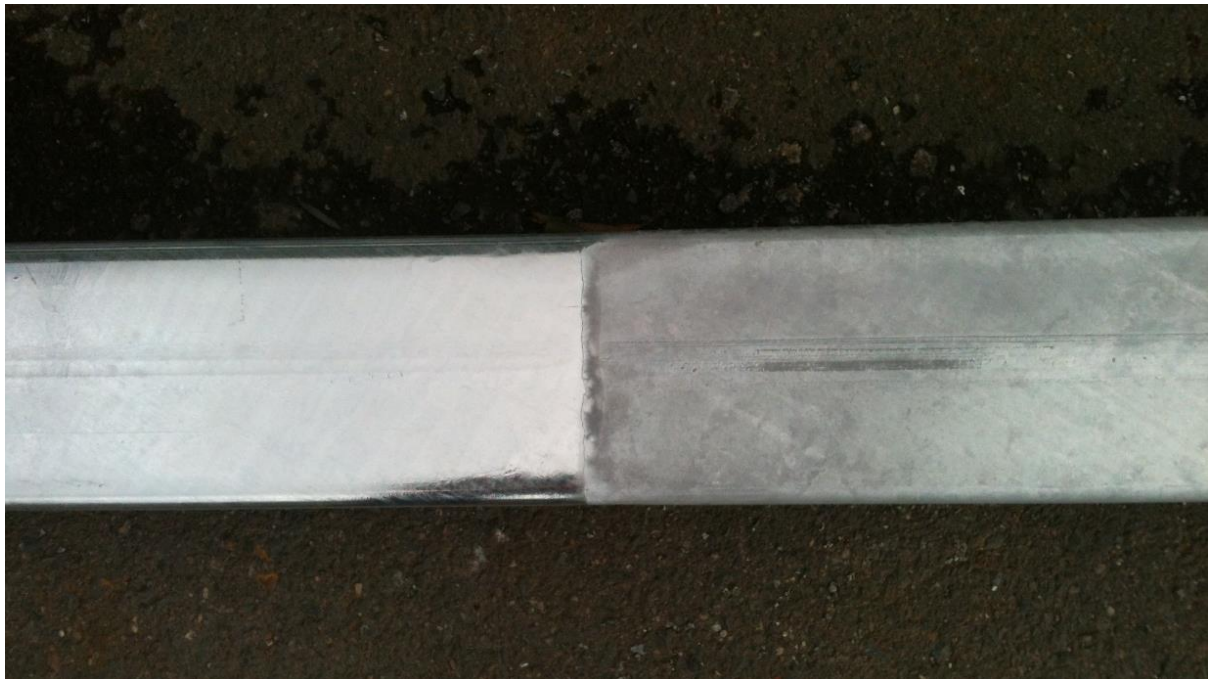
Figure 10: A close up of steel of different compositions being joined in a square hollow section, which is acceptable as long as the coating is sufficiently adherent.

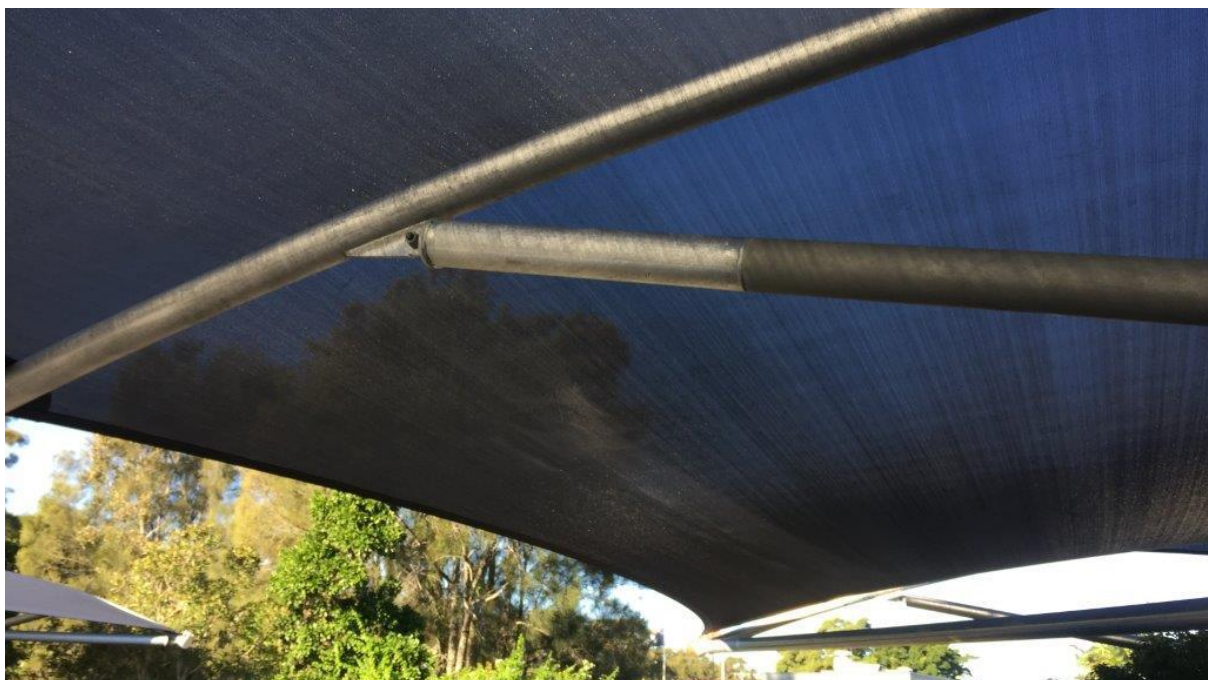
Figure 11: A circular hollow section comprising of steel with different compositions holding up a shade cloth. The colour different is purely aesthetic and has no influence on the corrosion resistance of the part.

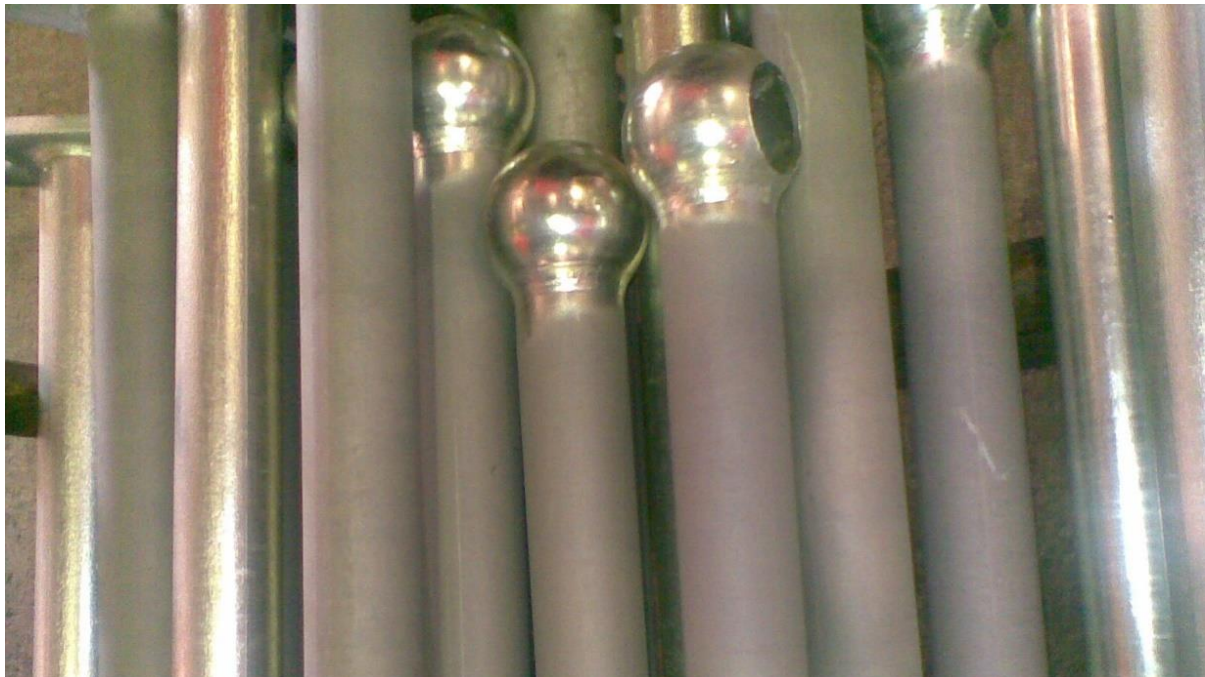
Figure 12: The round ball component of a handrail stanchion has been made from less reactive steel, resulting in a shinier appearance.
