# TECHNICAL NOTE

## Differing Appearance

Issue 1, April 2017

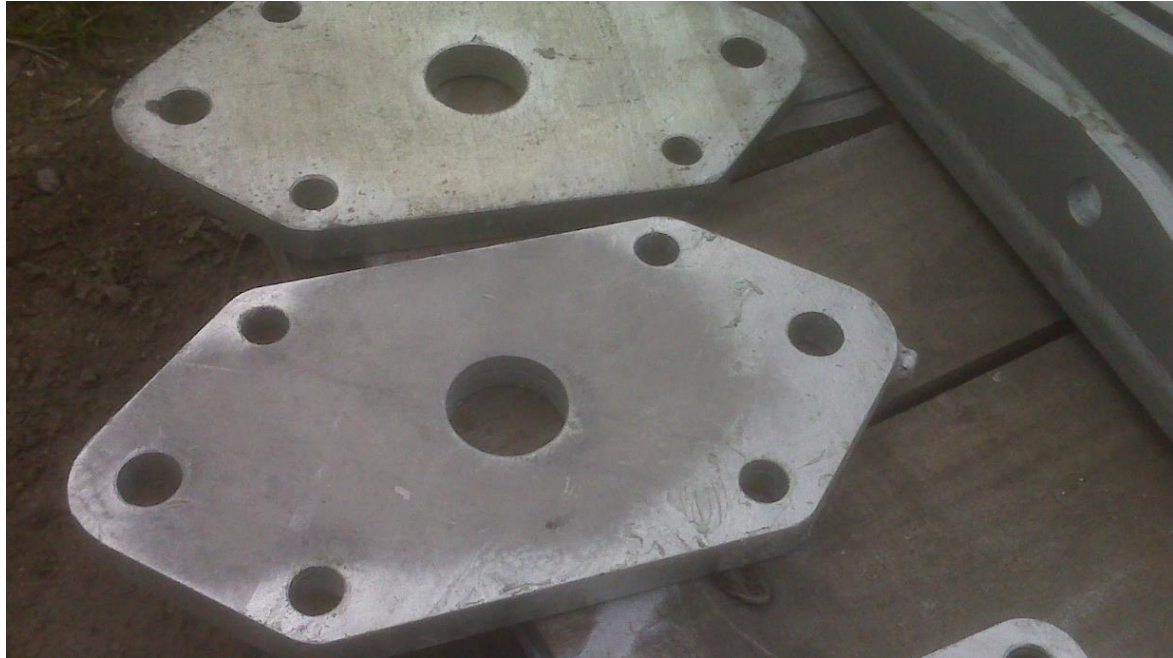
**Figure 2:** The thicker plate has cooled more slowly in the centre, causing a dull grey finish where alloy layers have grown to the surface.

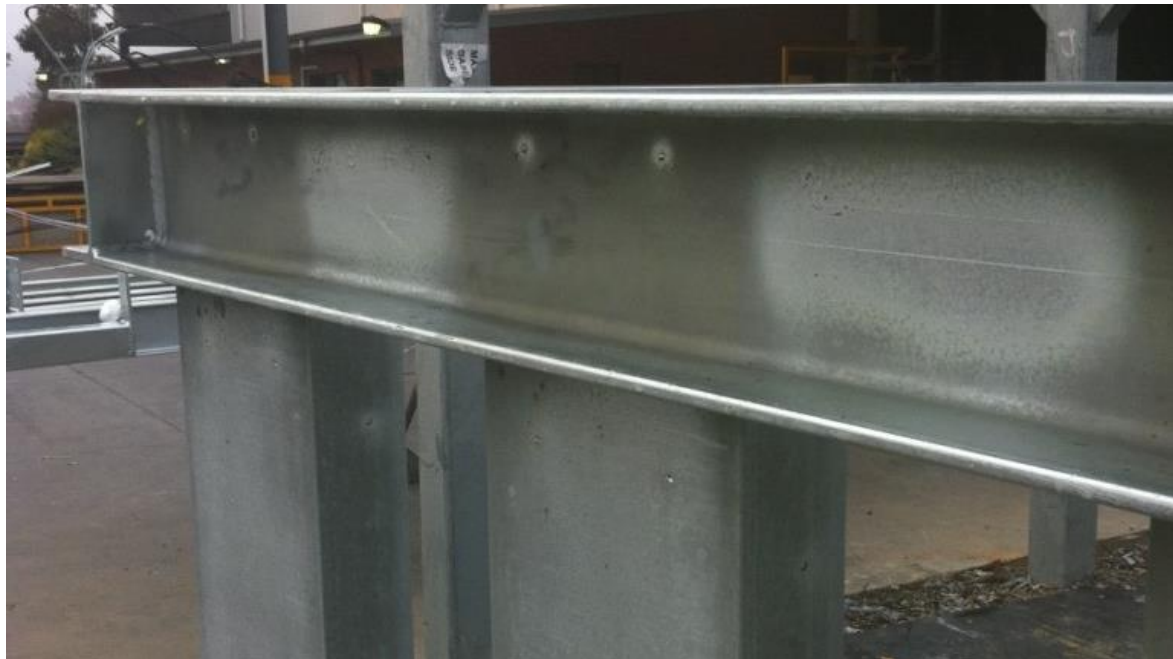
**Figure 3:** The thick steel behind the beam has caused slower cooling of the web in places, resulting in a duller coating.

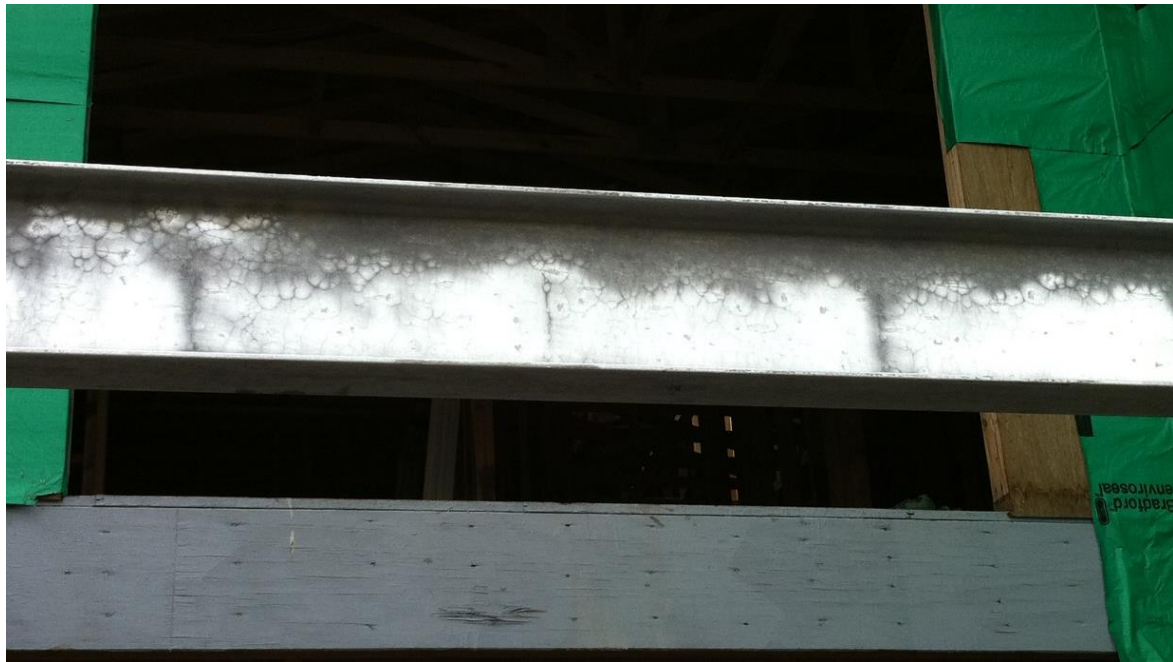
The cooling rate after galvanizing also influences alloy layer appearance. When articles have thicker steel areas, they retain heat for longer, which can allow the reaction between the zinc and steel to continue if the temperature stays sufficient. This can cause the alloy layers to grow to the surface in places and develop duller coatings as in Figures 2-3. While the article is being withdrawn, its lower surface may be exposed to radiant heat from the bath or molten zinc draining from the article for a longer period, especially if hung at an angle close to horizontal. This heat at the lower surface can allow the reaction between the zinc and steel to continue and result in a dull appearance. This is the probable cause for the appearance of the coatings seen in Figures 4-7.

**Figure 4:** The darker section of this beam has likely spent more time over the galvanizing bath while the zinc drains off. The mottled appearance is indicative of the alloy layers growing to the surface in some places.

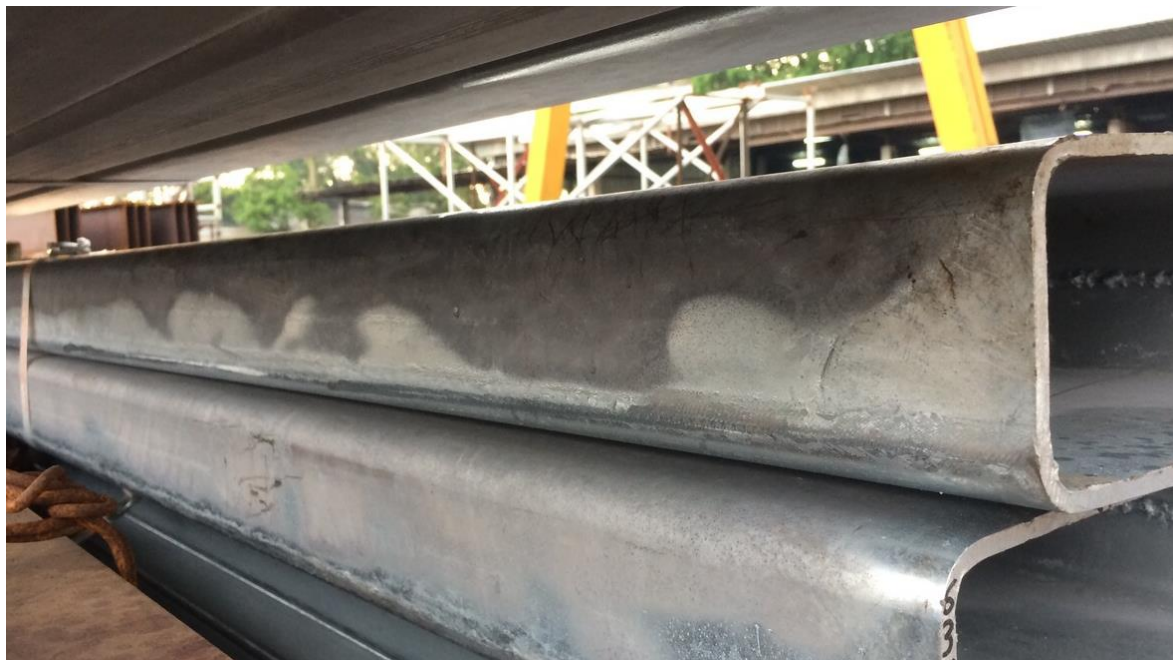
**Figure 5:** A well-defined barrier between shiny and dull sections could be a result of prolonged bath temperature exposure or the zinc cooling and losing fluidity during run off.

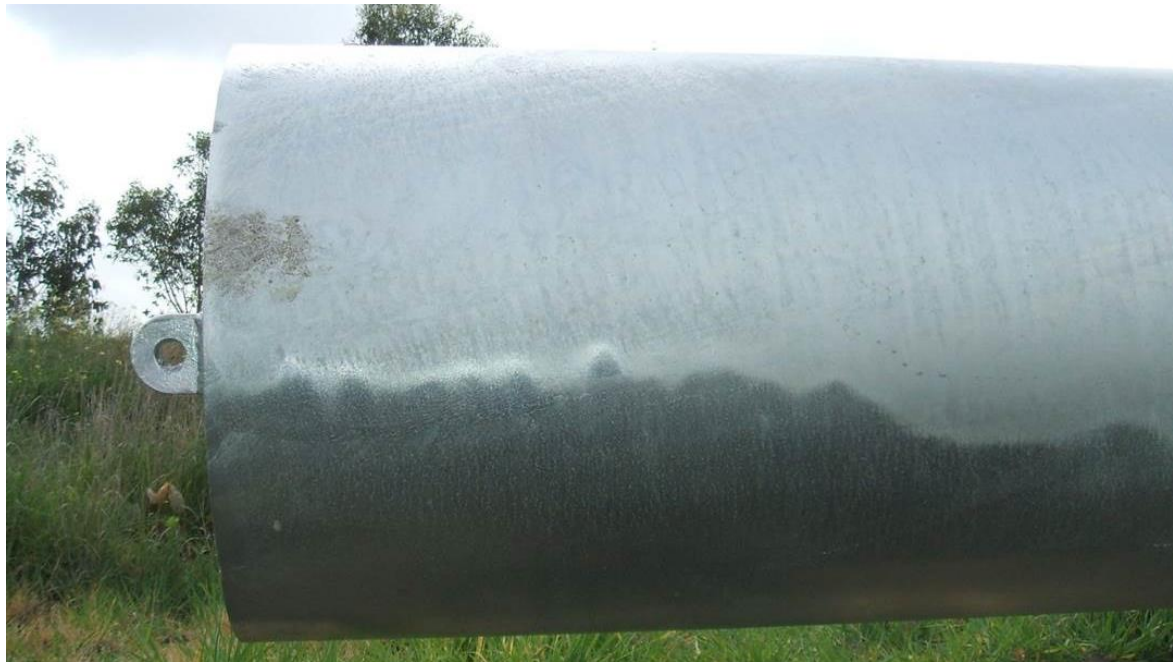
**Figure 6:** The duller section of the pipe has been exposed to the bath temperature for longer, with the shiny section consisting of pure zinc.

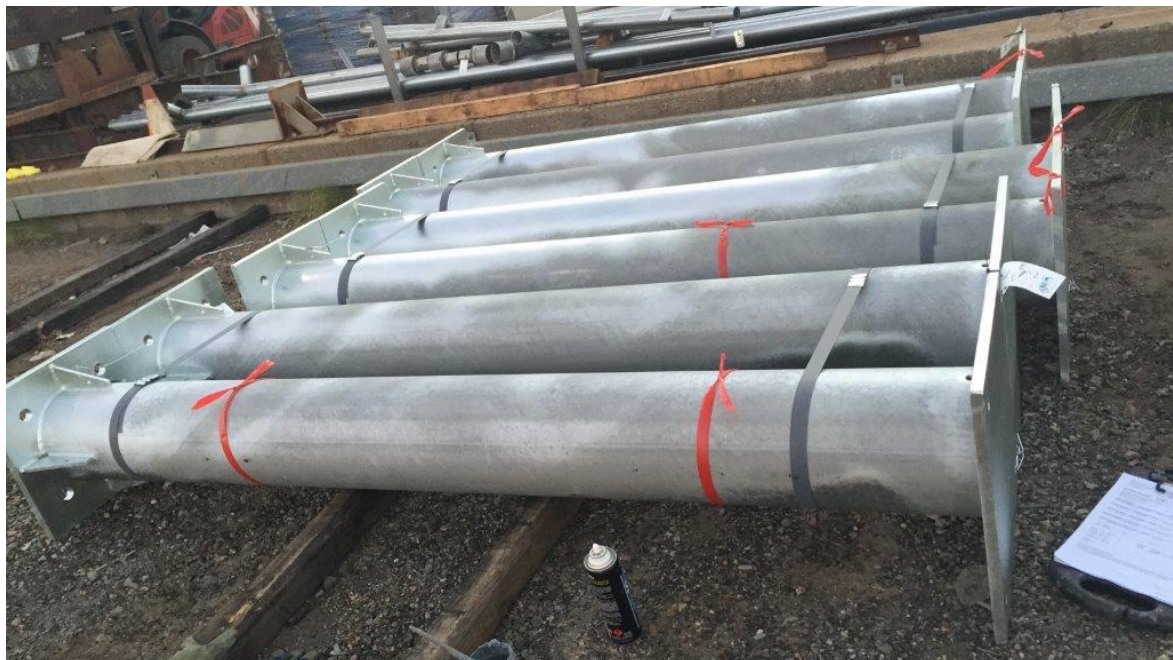
**Figure 7:** A small shiny section can be seen in the bottom right of the image, likely caused by the surface cooling at a different rate.

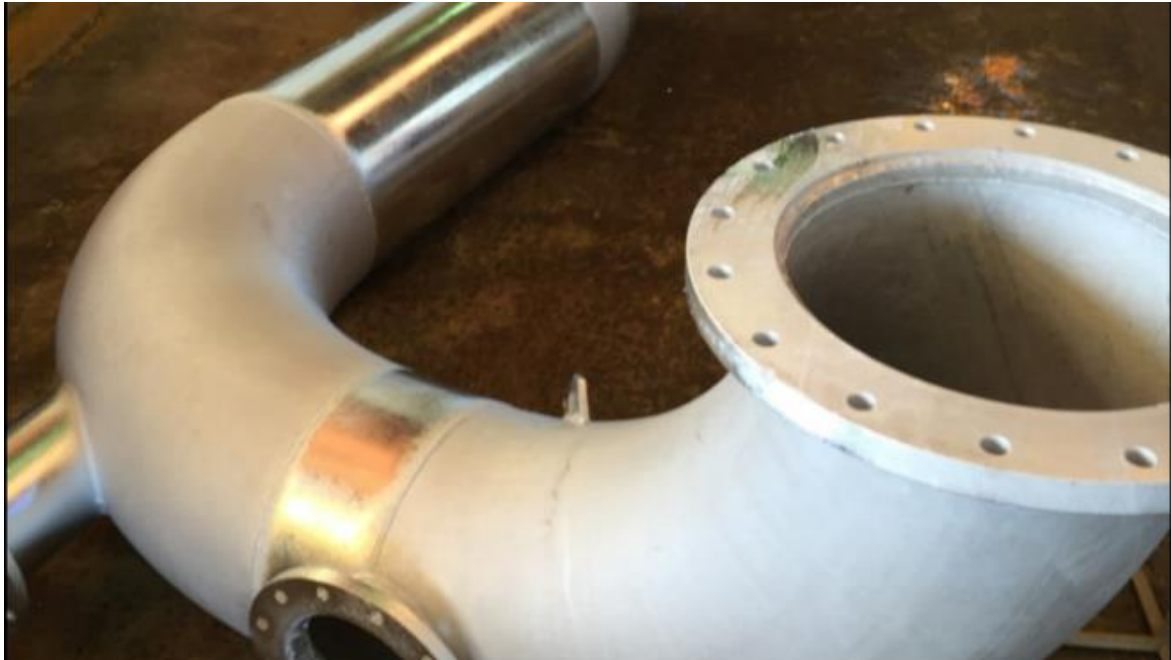
For a fabricated article, if the steel sections comprising the article have a large variation in steel composition (i.e. different sections use steel from different Categories in Table 9.1 of AS/NZS 2312.2), their differing reactivity will generally result in a varied appearance across the different steel sections, as seen in Figures 8-12.

**Figure 8:** Steels with different chemical compositions on the straight and curved sections have been used, resulting in the straight sections being shiny and the curved sections dull.

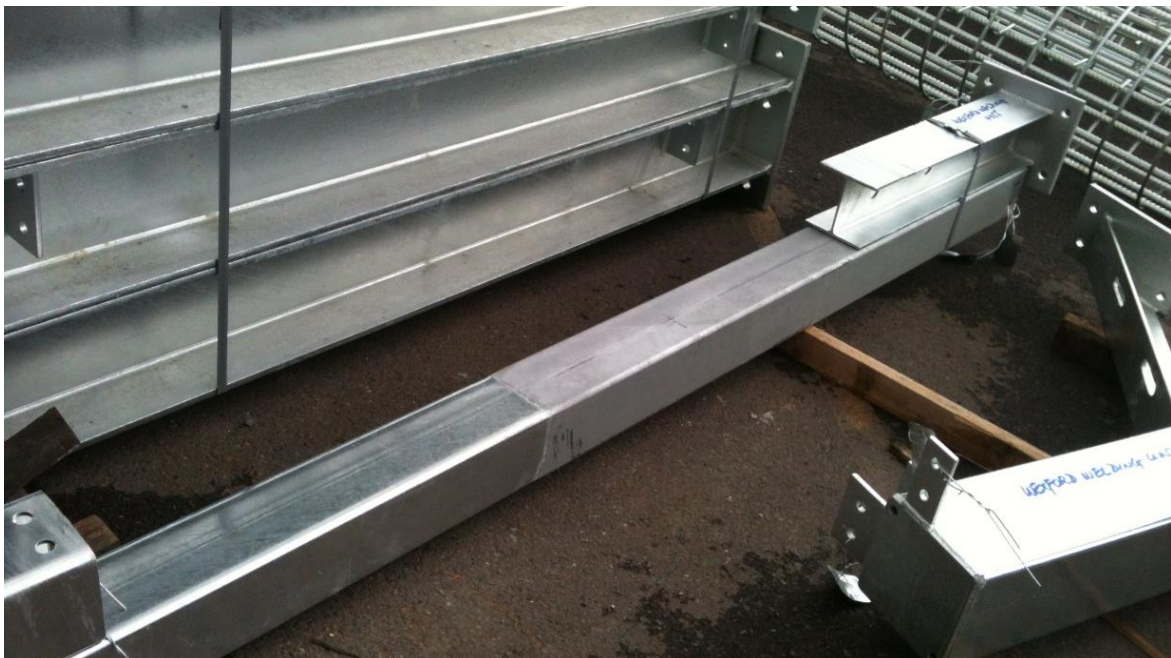
**Figure 9:** Steels of different compositions have been welded together in a straight square hollow section, resulting the differing appearance.

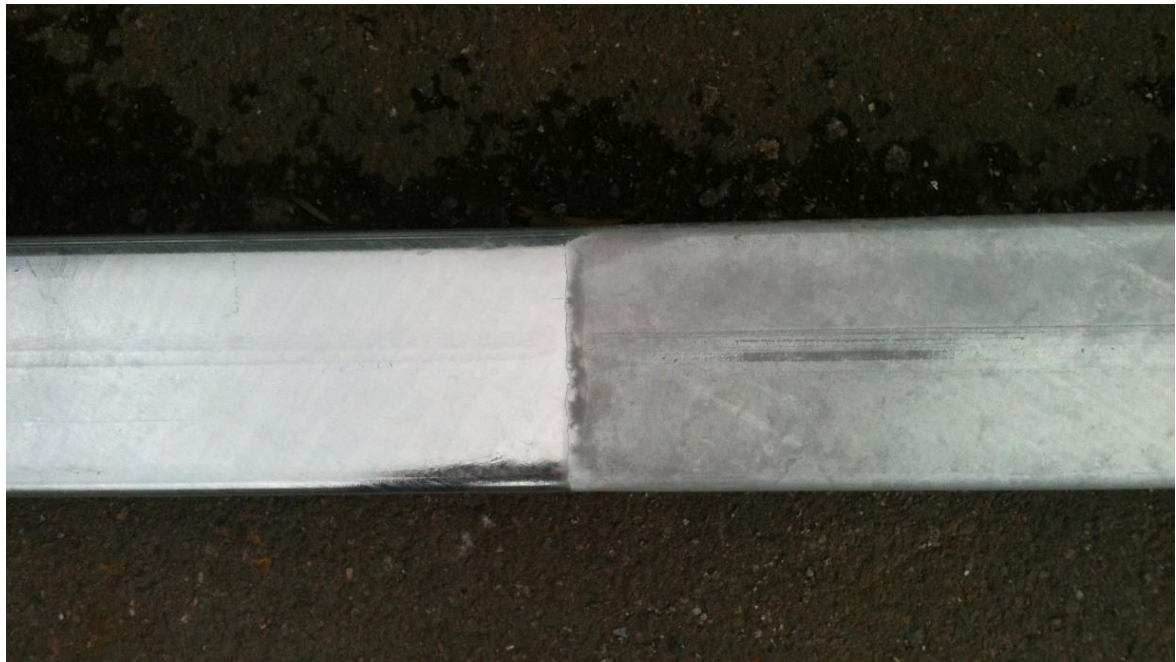
**Figure 10:** A close up of steel of different compositions being joined in a square hollow section, which is acceptable as long as the coating is sufficiently adherent.

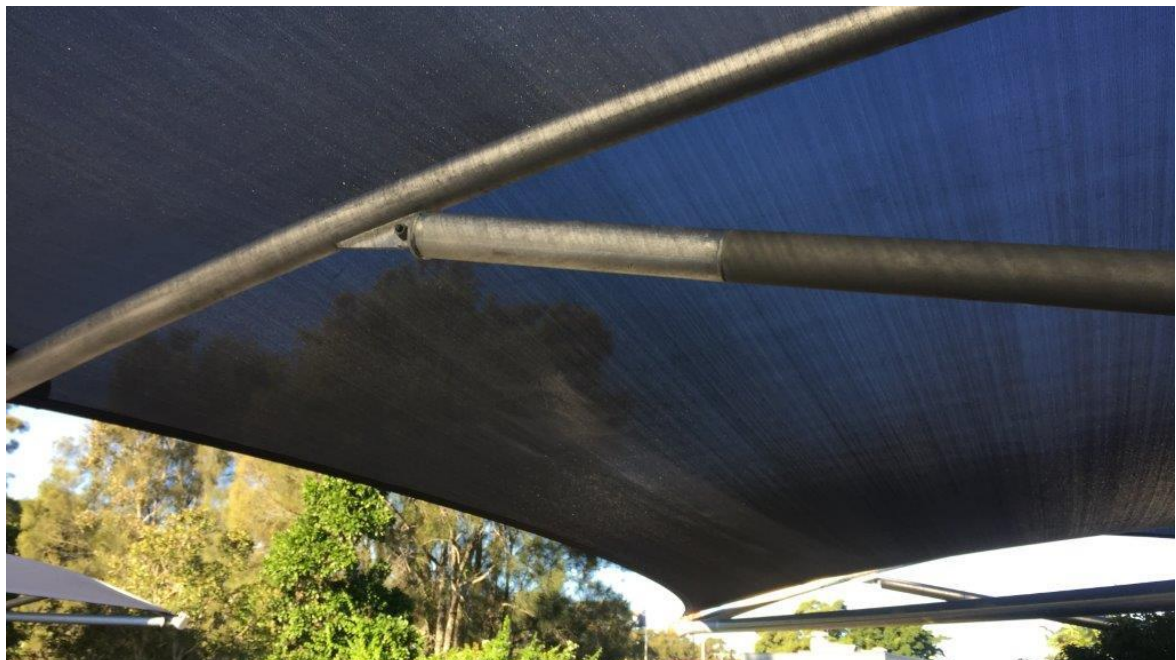
**Figure 11:** A circular hollow section comprising of steel with different compositions holding up a shade cloth. The colour different is purely aesthetic and has no influence on the corrosion resistance of the part.

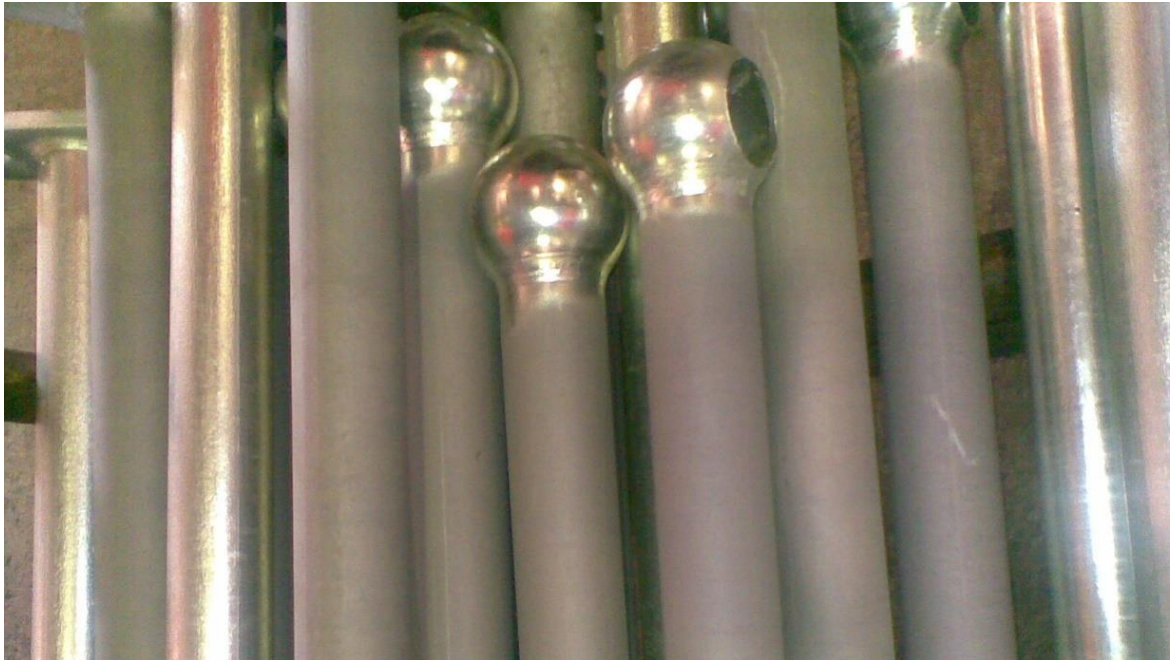
**Figure 12:** The round ball component of a handrail stanchion has been made from less reactive steel, resulting in a shinier appearance.
