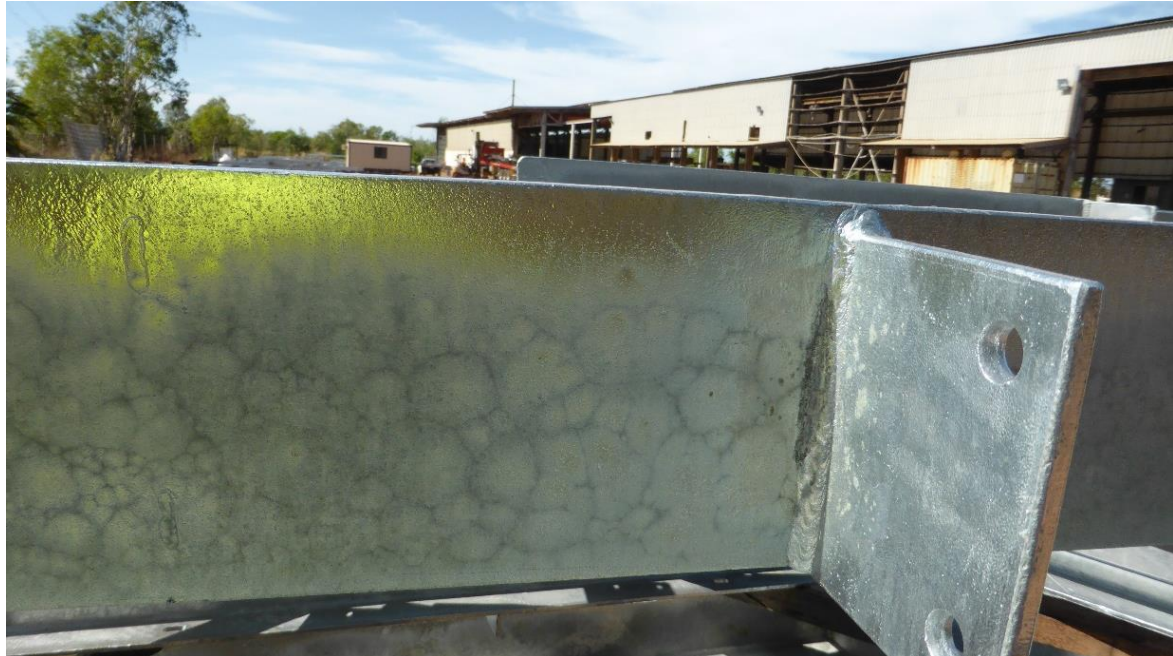
Figure 1: The dark circular pattern of a mottled appearance is visible, with the dark sections being regions of iron-zinc alloy layers on the surface.

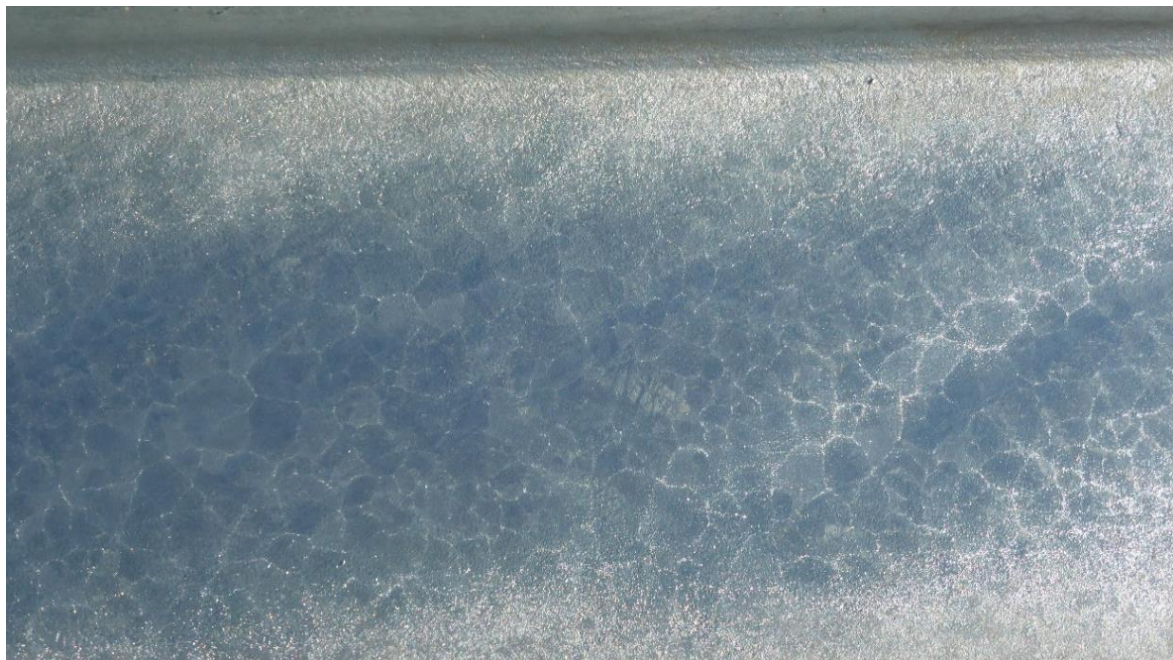
Figure 2: A close up of a mottled appearance, showing the difference between the shiny and dull regions.

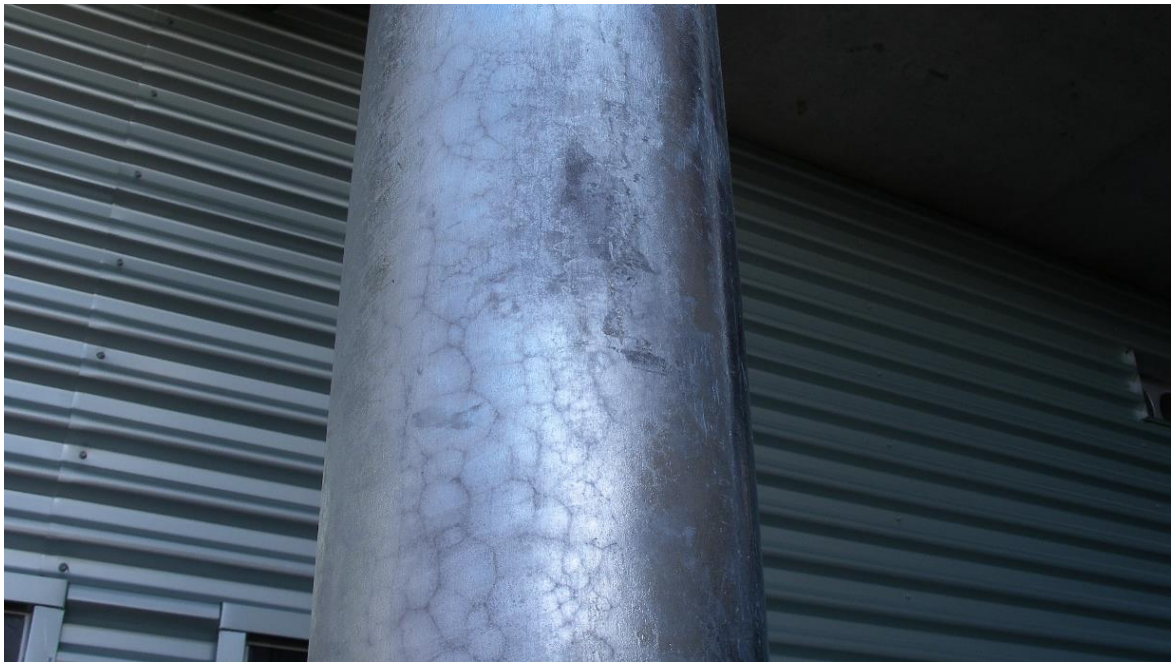
Figure 3: Mottled appearance on a pipe, most likely due to the steel chemistry.

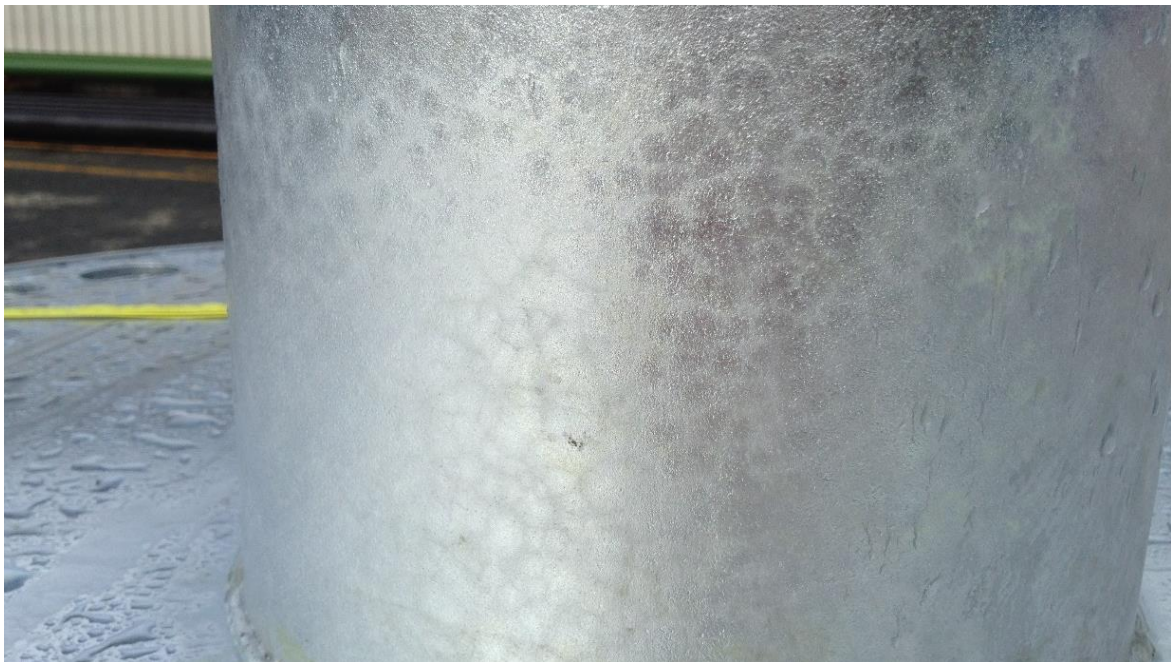
Figure 4: The scale like mottled appearance evident on a circular article.

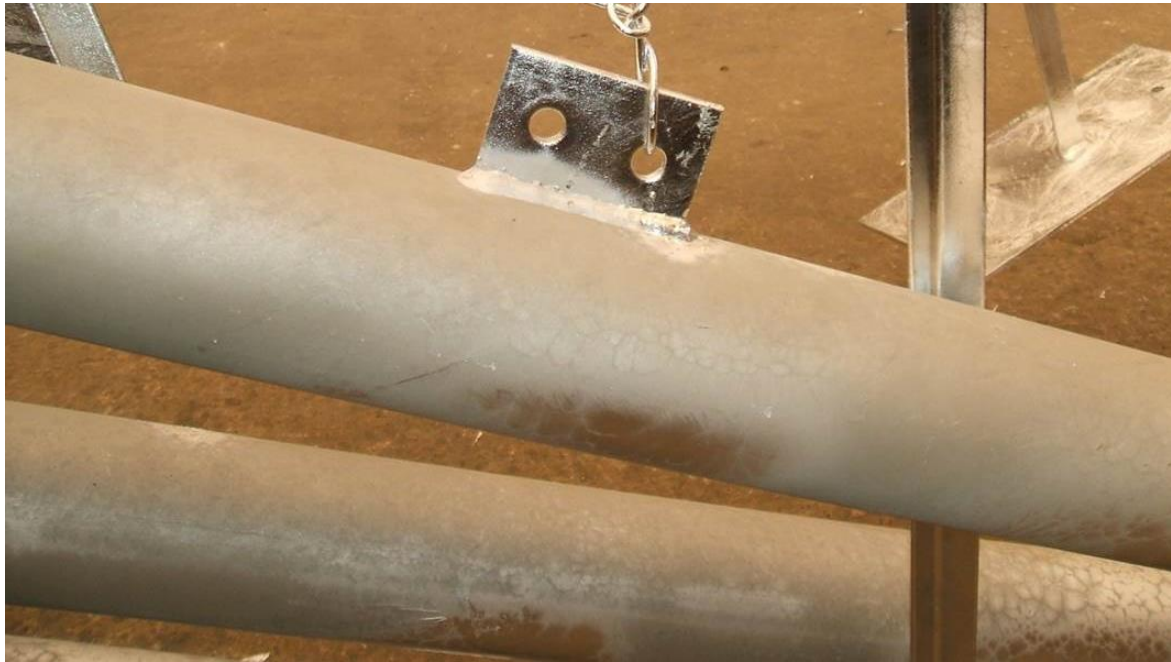
Figure 5: A mottled appearance has occurred in some regions on the pipe in combination with a dull coating (see *Dull Grey Appearance*).
