# TECHNICAL NOTE

## Flaking

Issue 1, May 2018

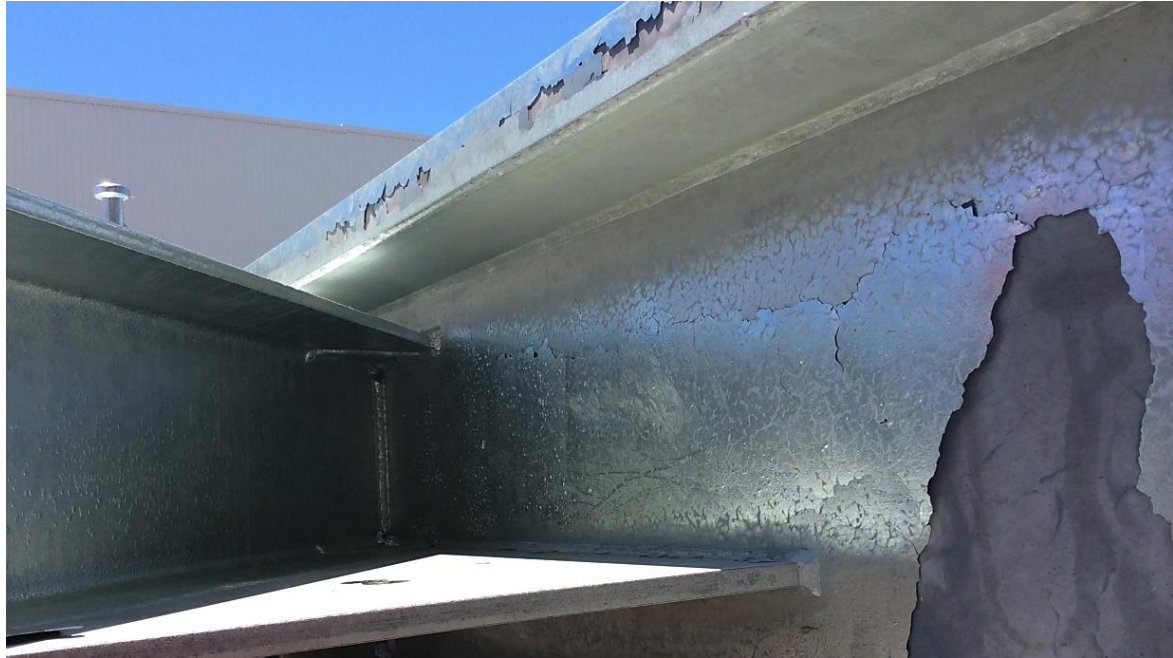
**Figure 1:** The galvanized coating is flaking off on multiple places of the article. Depending on the size of the bare spots and end use it may need to be regalvanized.

- Small bare spots being repaired using a method from Clause 8.2 of AS/NZS 4680 when the end use isn't affected
- Rejected articles can be stripped of the galvanized coating and regalvanized, with the part potentially being air cooled instead of quenched as a preventative measure for thick steels, however there is a chance flaking will occur again. If the issue is suspected to be unavoidable due to steel chemistry, the remedy should be discussed between the customer and galvanizer
- Flaking occurring as a result of fabrication after galvanizing is not the galvanizers responsibility as per Clause 10 of AS/NZS 4680, and the remedy should be discussed with the galvanizer
- When flaking is a result of handling damage, the remedy should be discussed with the galvanizer

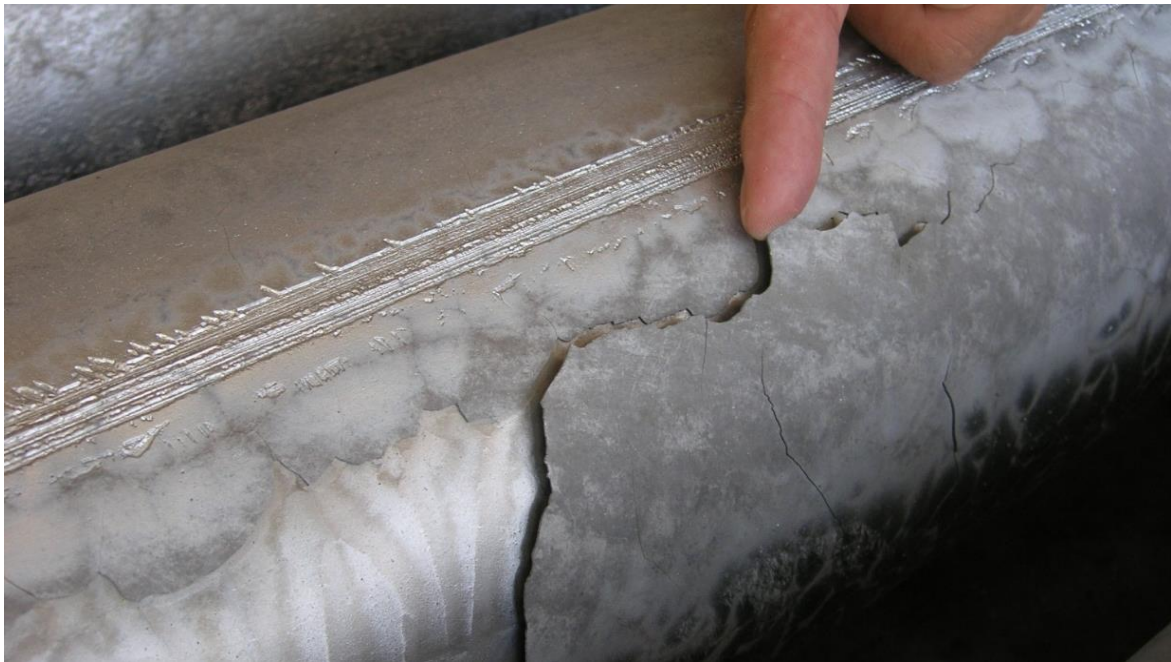
**Figure 3:** The zinc coating is flaking off a fabricated pipe due to the steel chemistry. The mottled grey appearance is indicative of a silicon content between 0.04% and 0.14% (see *TN Mottled Appearance*).

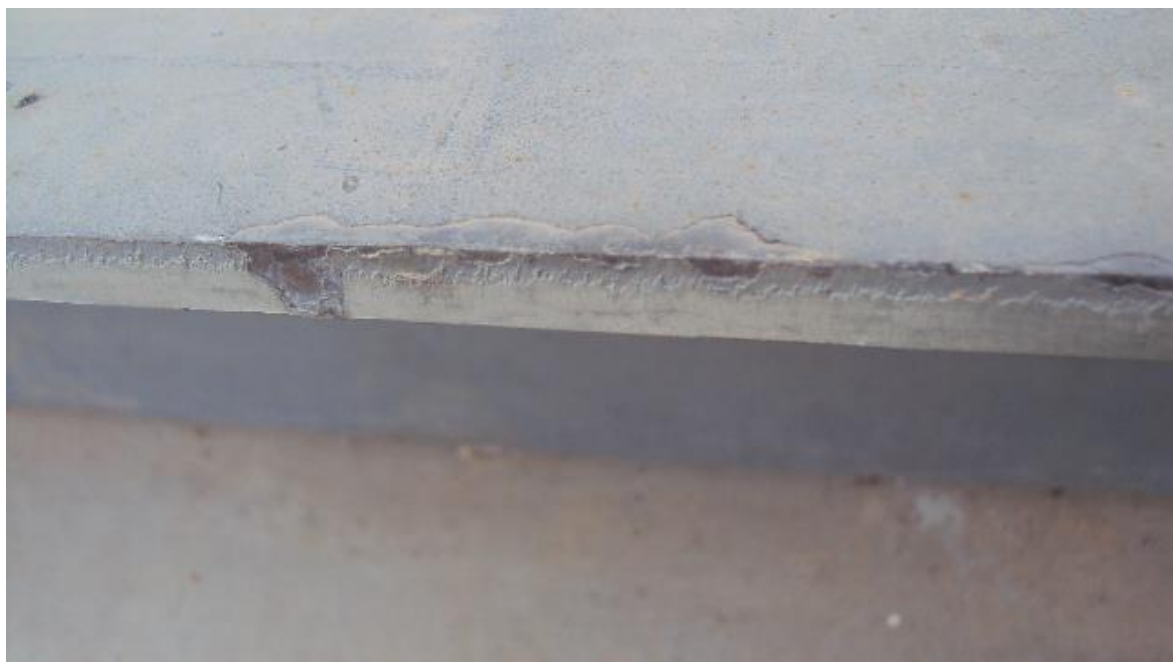
**Figure 6:** Handling damage has caused flaking near the edge of the galvanized article.

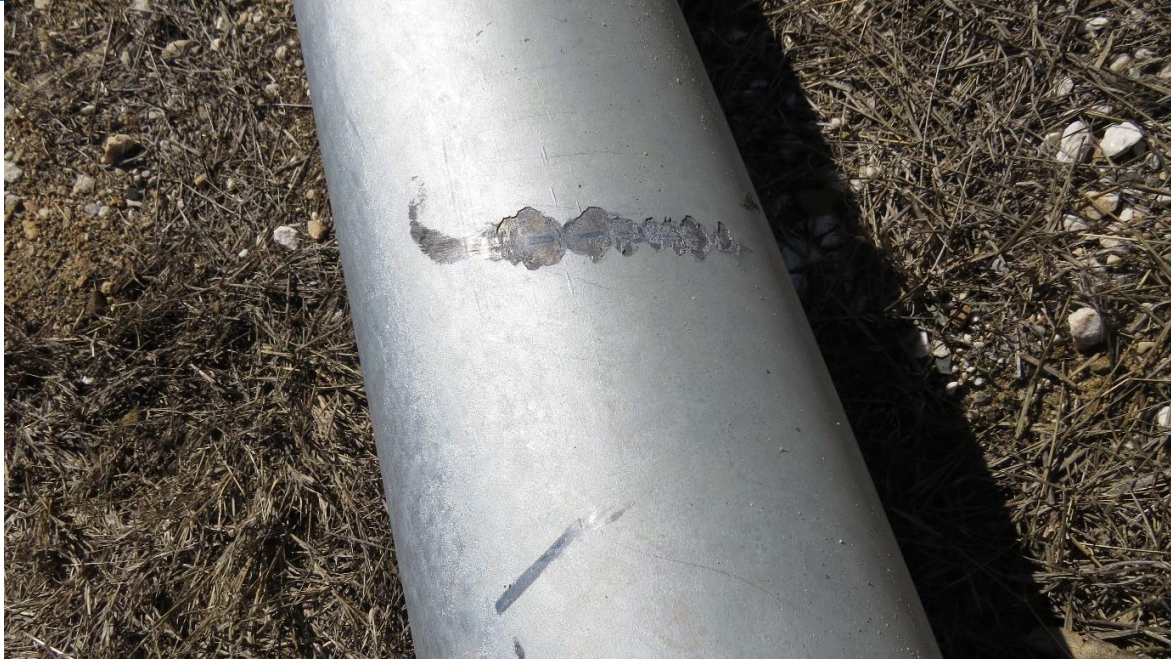
**Figure 7:** Impact during handling has caused flaking of the thick, brittle galvanized coating.
