Double dipping Process

The description of 'double dipping' in our manual is as follows:

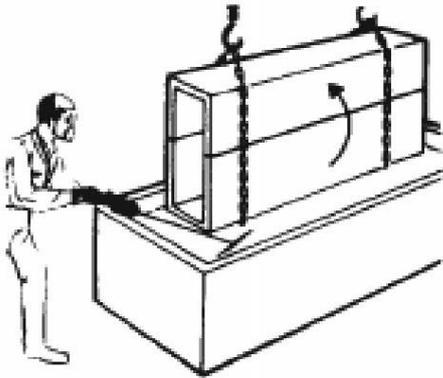
Double-end dipping for excess depth

Double end or depth dipping is a term used to describe the process of galvanizing an item which is longer or deeper than available bath dimensions. In this procedure the item is lowered into the bath so that half or more of its length or depth is immersed in the zinc bath. When the zinc coating has been achieved, the item is raised from the bath and adjusted in handling so that the ungalvanized part can be immersed in the bath. It should be noted that in this procedure an overlap of zinc coating will occur and this may have to be addressed in the case of visually obvious structural elements that require an aesthetic finish.

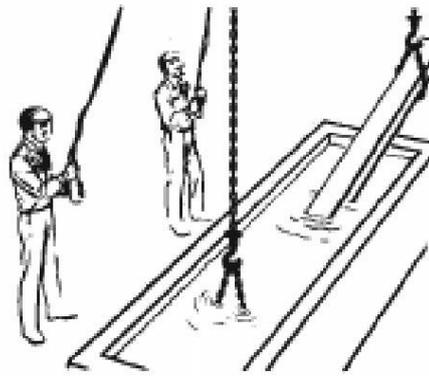
Double-end dipping for excess length

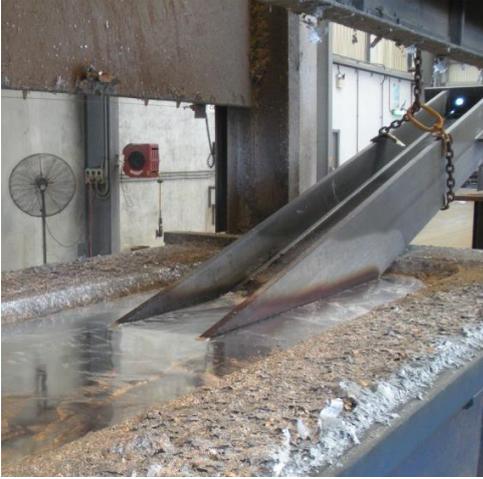
Photo 1

Photos 1 and 2 show the first stage, where one end is being immersed in the molten zinc while the excess length remains bare steel. After an article is removed from the zinc, at this stage it may or may not be quenched. This decision may be influenced by various factors, including the risk of distortion.

The five photos below show an example of a beam too long for the zinc bath which was double dipped.

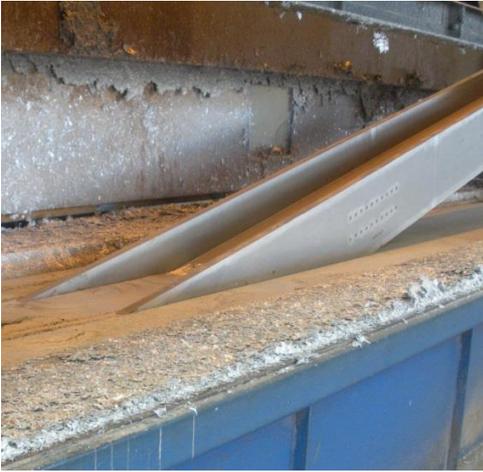
Photo 3 shows the part of the beam that wasn't galvanized (in Photos 1 and 2) immersed in the molten zinc. Photo 4 shows a distinct difference in appearance between the parts of the beam galvanized at different times as the beam is being withdrawn from the molten zinc for the second time.

When able, the article would be turned around and/or re-hung. Typically, the part of the article that still needs to be galvanized will be re-fluxed before being dipped into the molten zinc.

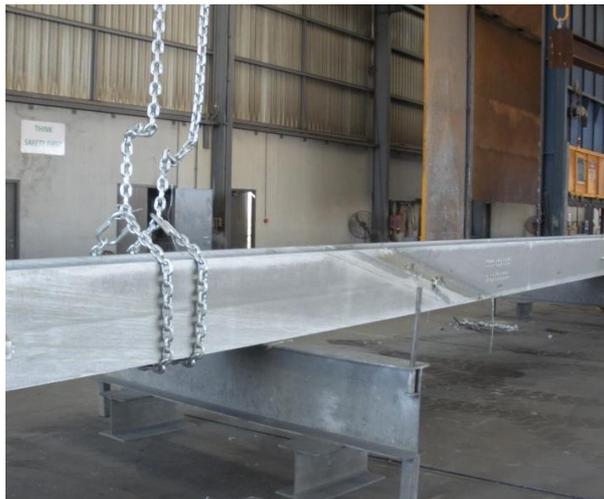
Photo 5 shows the whole beam after both ends were galvanized. The appearance of the galvanized coating on the right side of the 'double dip line' is duller due to the fact that it was galvanized first and, mostly likely due to slow cooling, the zinc-iron alloy layers of the galvanized coating have continued to form and consumed much of the zinc which was on the surface upon withdraw from the zinc bath before it solidified.
